Geological Solutions Providing a Scientific Basis for Differing Site Condition (DSC) Claims

ASCE Metro NY Conference
26 May 2022

Can Geologic Studies Help Explain Excavation Anomalies and Support DSC^{s}?

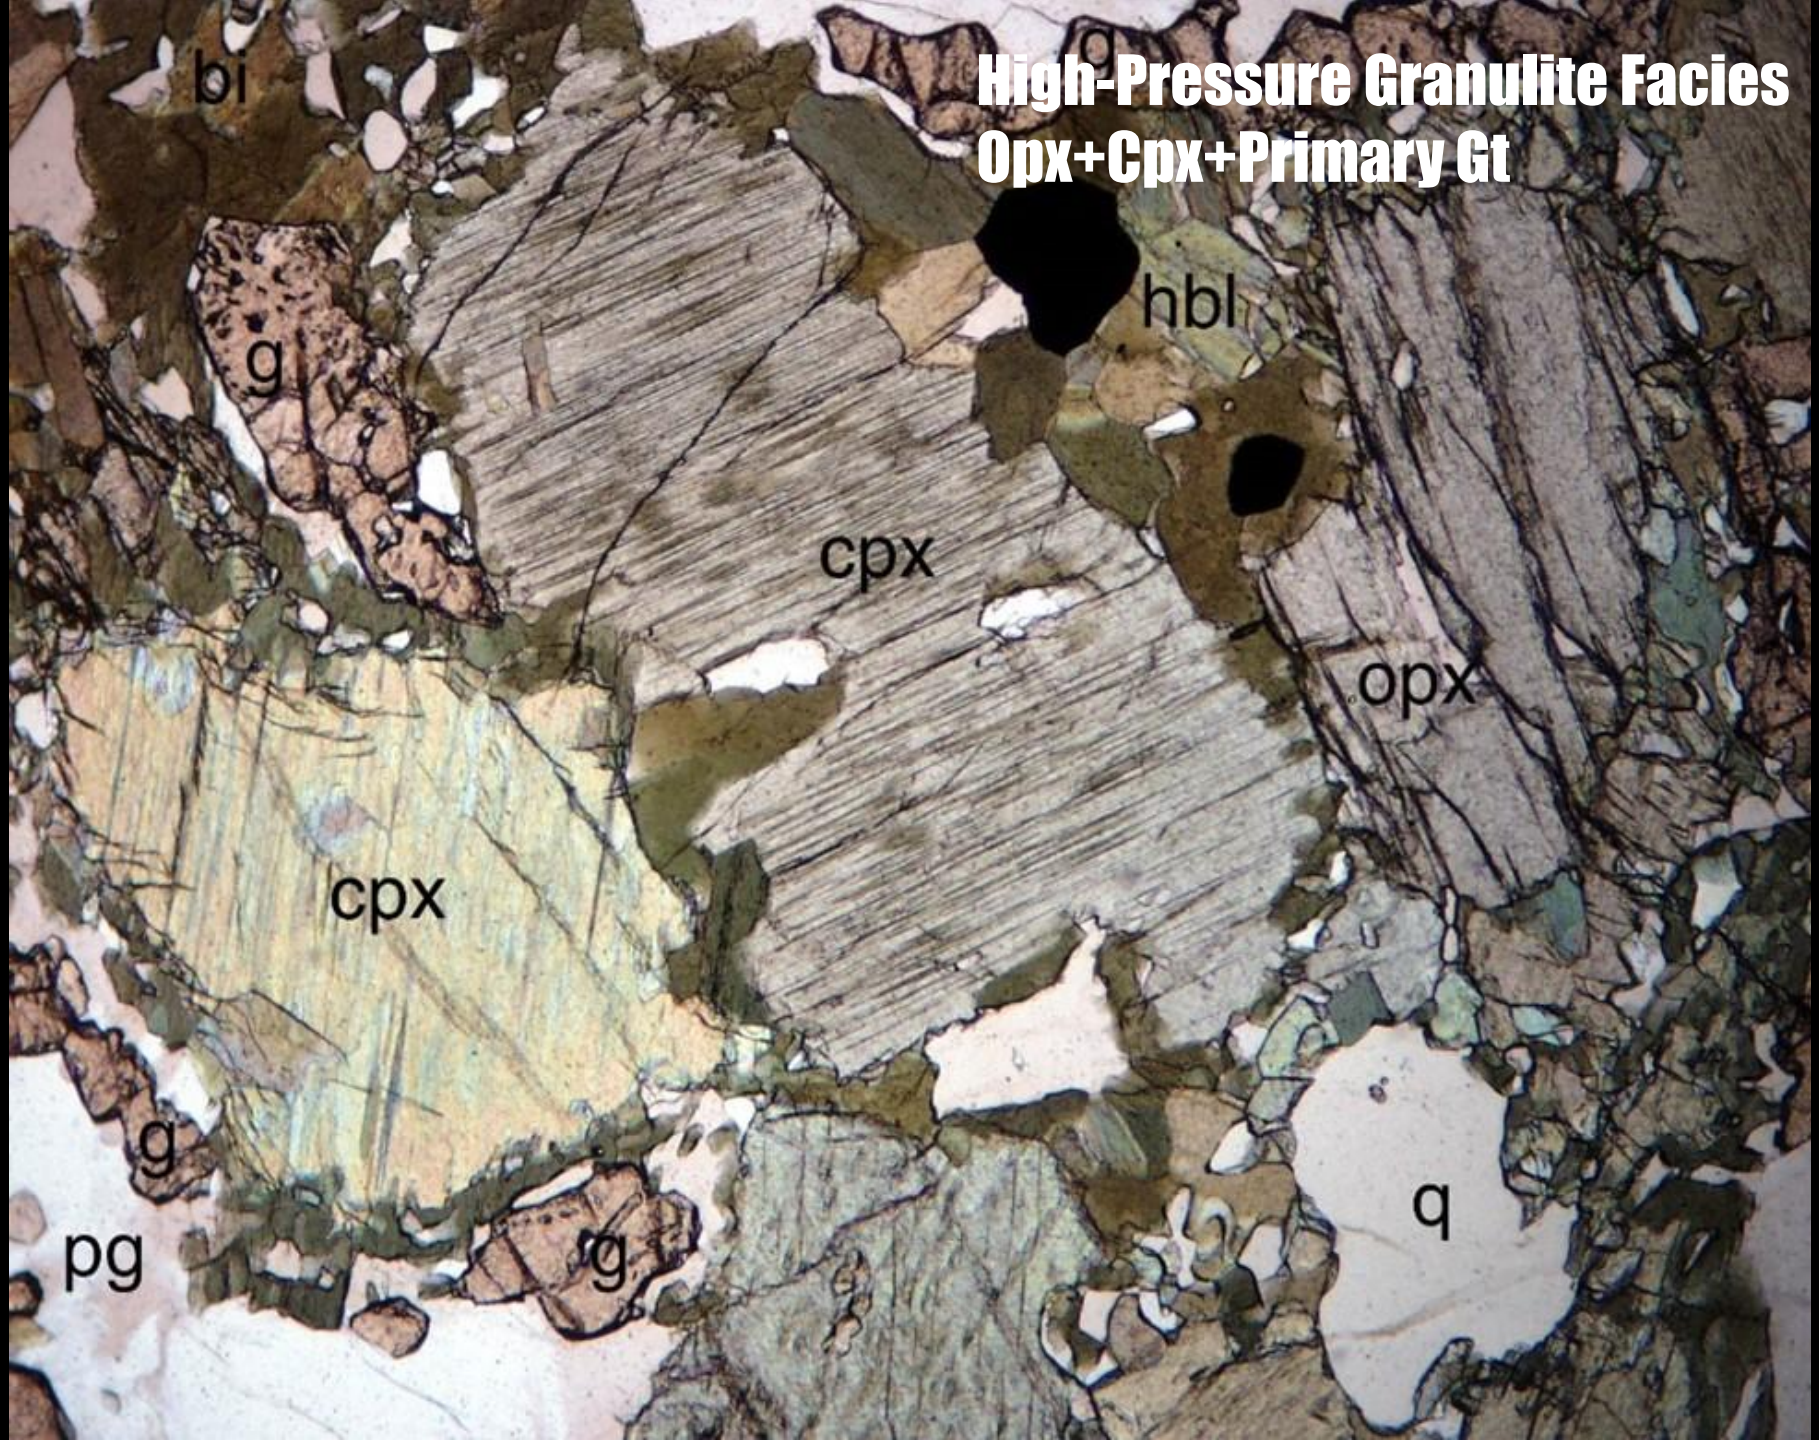
High-Pressure Granulite Facies
Opx+Cpx+Primary Gt
bi
g
hbl
cpx
opx
cpx
g
pg
g
q

High-Pressure Granulite Facies Metamorphism Produced Broad Zones of Anomalous Garnet, Higher Density, Lower Production, Excessive Fines

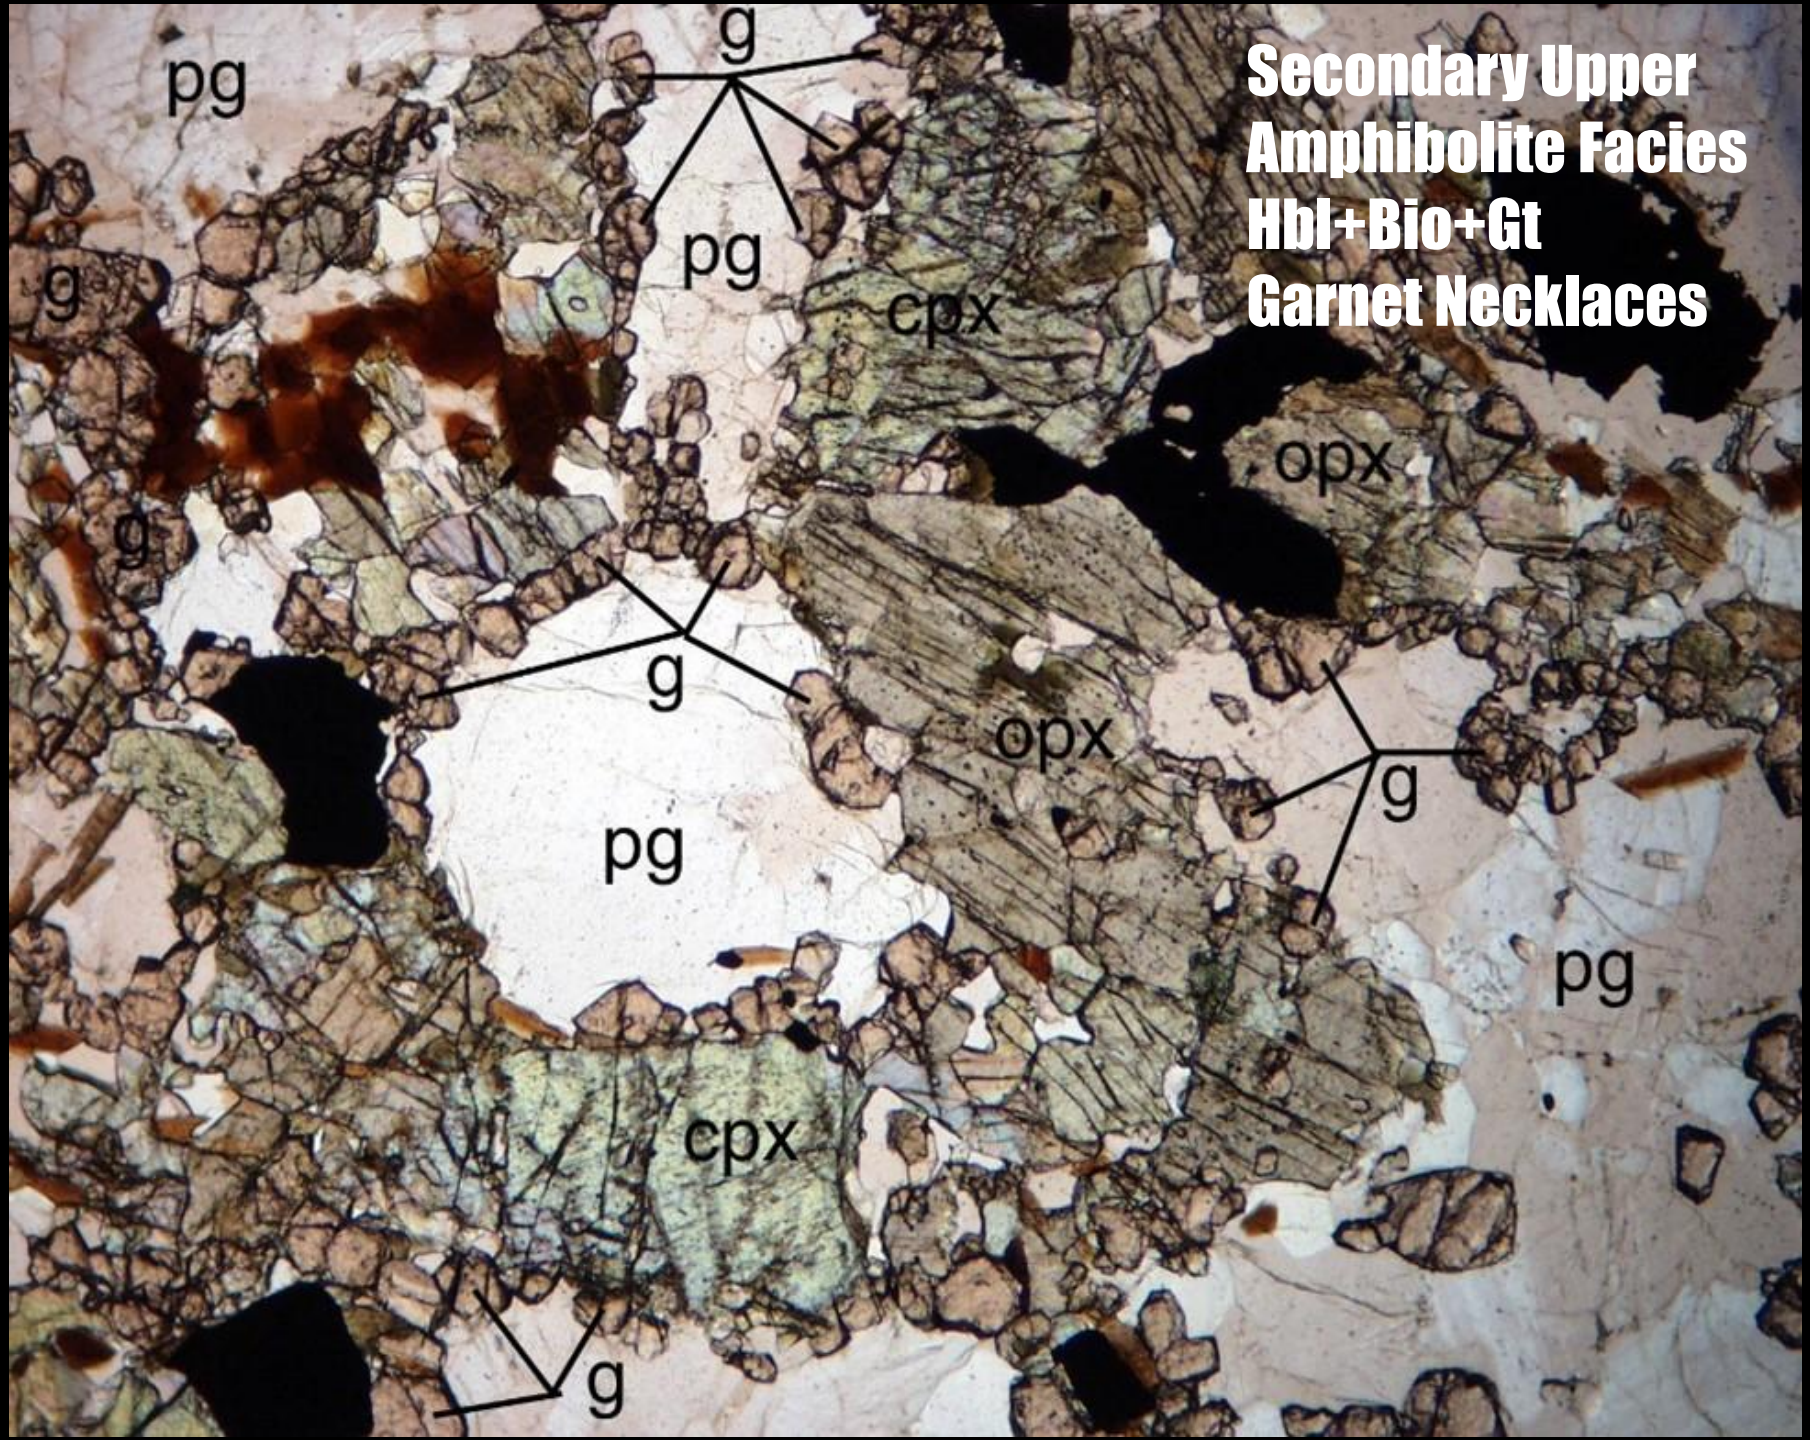
Secondary Upper
Amphibolite Facies
Hbl+Bio+Gt
Garnet Necklaces
pg
g
pg
cpx
g
opx
g
g
opx
g
pg
pg
cpx
g

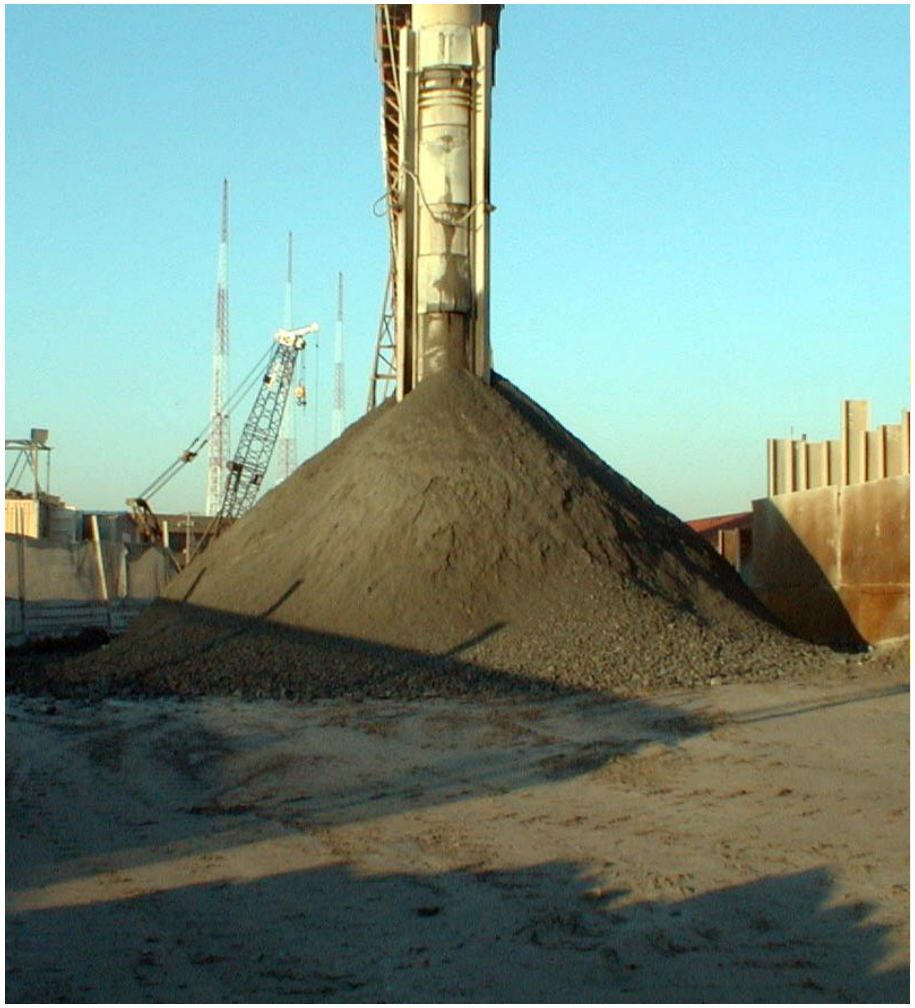
~11% of Tunnel up to 50% Garnet
in 32 Zones (= Ore Deposit!!)
Abrasive, Tough Granoblastic Rock Mass =
Low Penetration Rate of <6'/hour vs.
9'/hour Anticipated and Excessive Fines
Bimodal Blocks and Dust

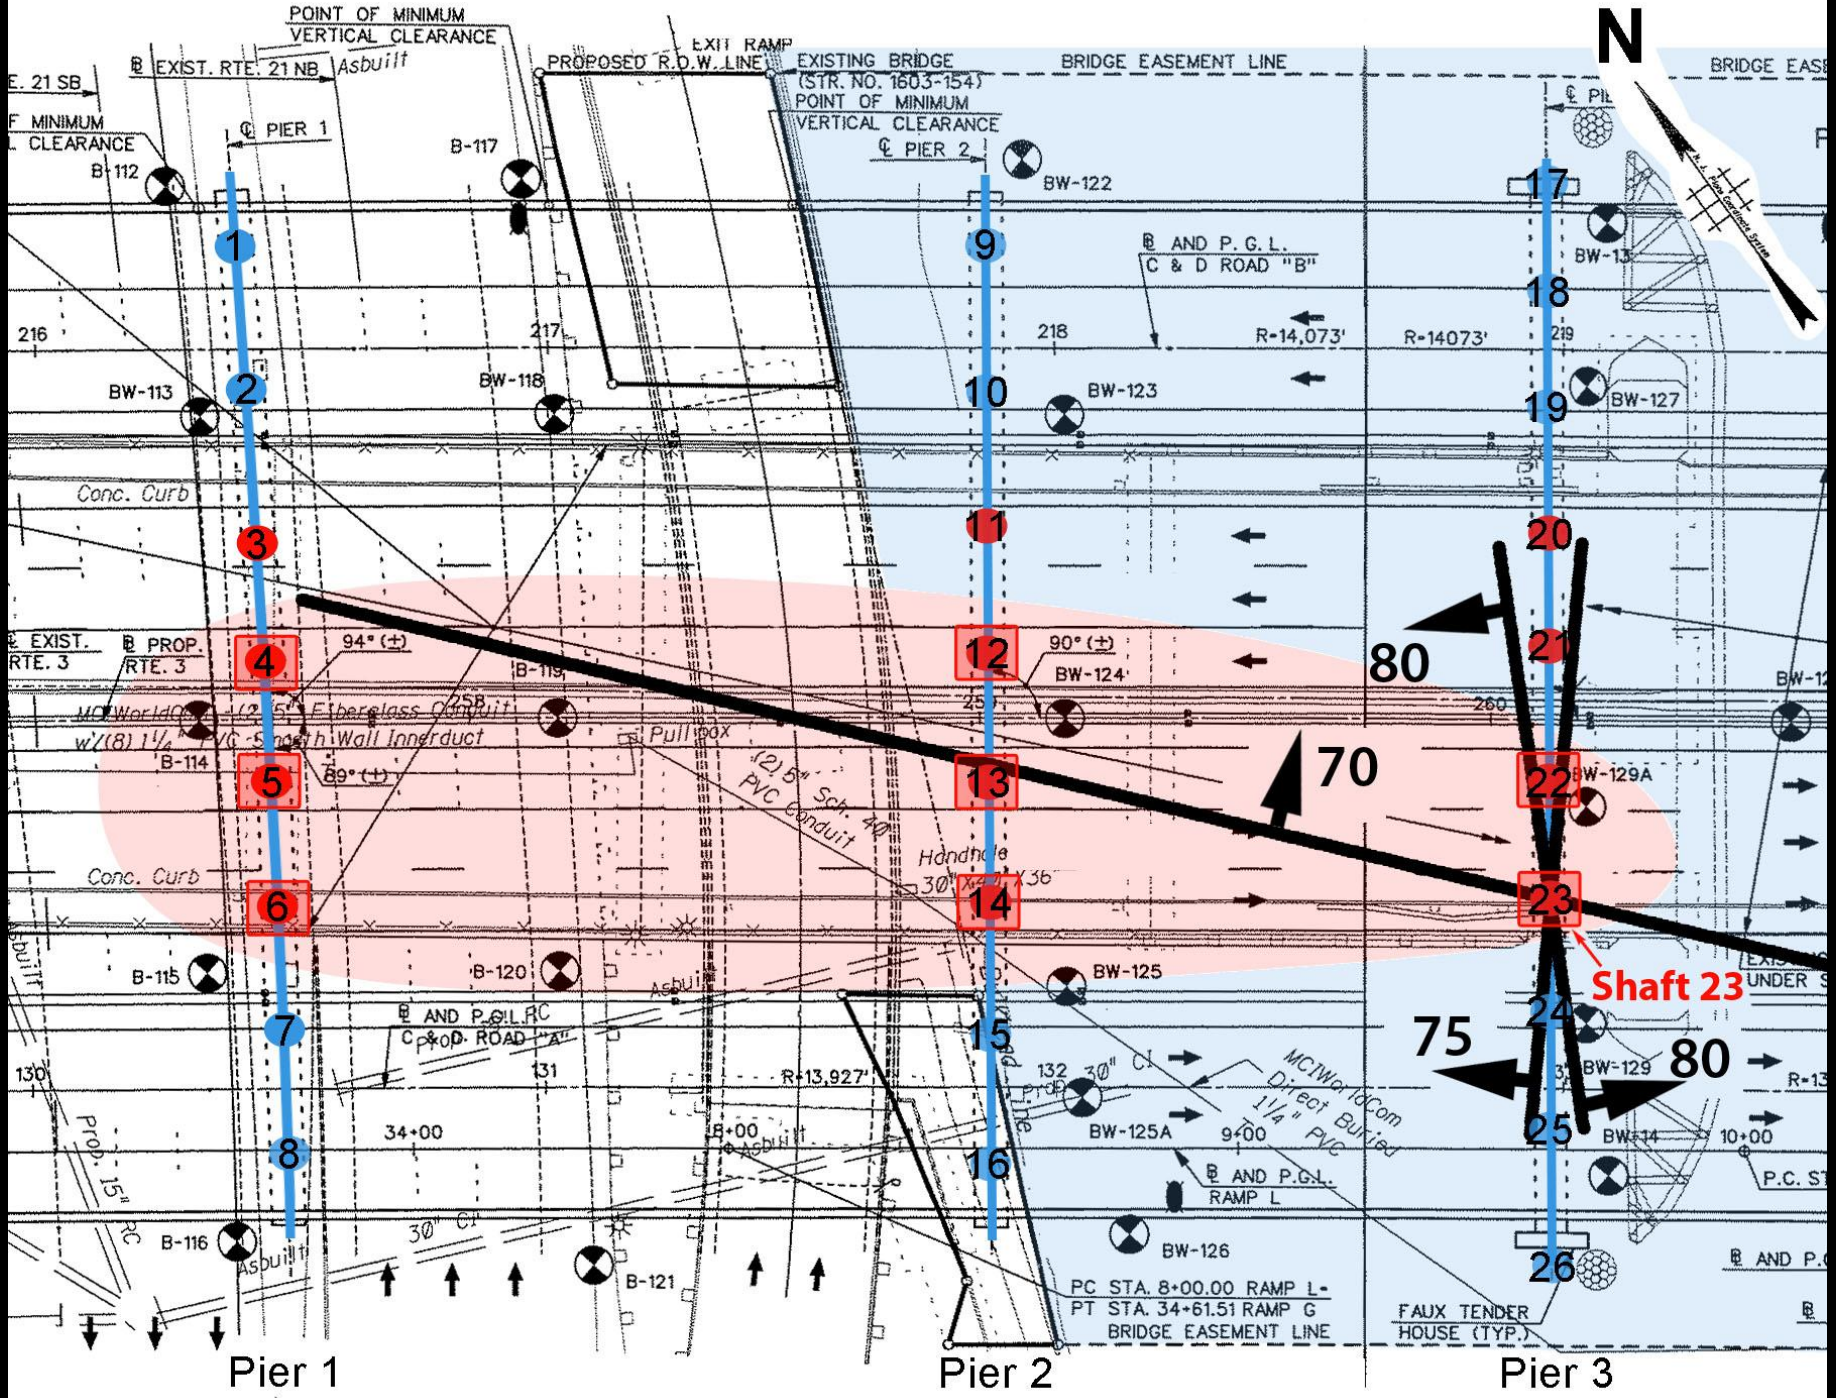
N
8 Shafts Encountered Serious Drilling Problems
Shaft 23
Pier 1
Pier 2
Pier 3
POINT OF MINIMUM VERTICAL CLEARANCE
EXIST. RTE. 21 NB
PROPOSED R.O.W. LINE
EXISTING BRIDGE (STR. NO. 1603-154)
BRIDGE EASEMENT LINE
PIER 1
PIER 2
B-112
B-117
BW-122
BW-113
BW-118
BW-123
BW-127
BW-124
BW-129A
B-114
B-119
B-115
B-120
BW-125
BW-125A
BW-126
B-116
B-121
BW-129
BW-14
BW-13
Conc. Curb
Pull Box
R-14,073'
R-13,927'
34+00
9+00
10+00
PC STA. 8+00.00 RAMP L
PT STA. 34+61.51 RAMP G
BRIDGE EASEMENT LINE
FAUX TENDER HOUSE (TYP.)
MCIWorldCom Direct Buried 1 1/4" PVC
RAMP L
C & D ROAD "B"
C & D ROAD "A"
EXIST. RTE. 3
PROP. RTE. 3
94° (±)
90° (±)
89° (±)
30" CI
Prop. 15" RC
Asbuilt

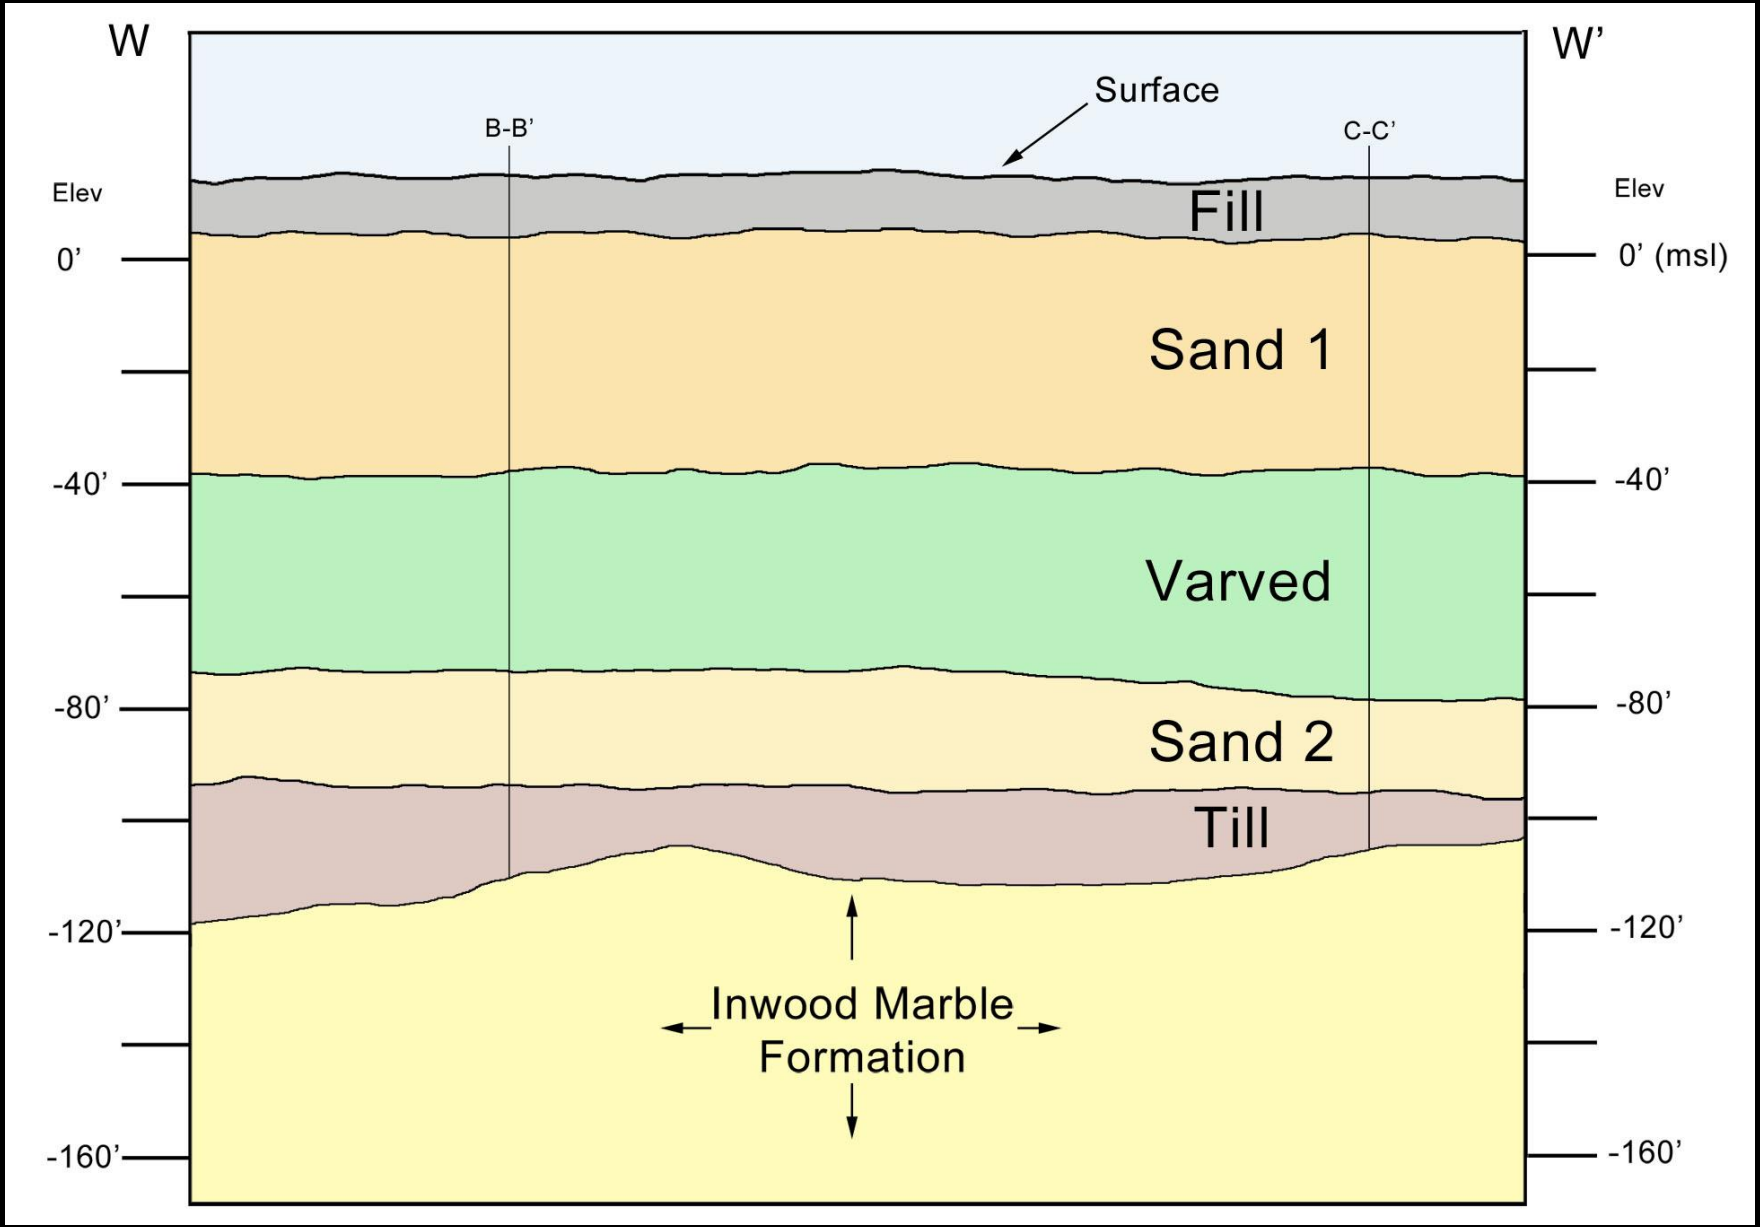
- "heavy water, sand, and rock”
- “excessive water from casing”
- “thick (heavy) sediment inflows up to 25 feet”
- “seams and rock ledges”
- “large rocks and dirty discharge”
- “socket making water”
- “communication between open drill sites”
- “flooding of the jobsite”
- “spoils on the ground”
- “equipment damage including broken shoes, rig tilting, hammer clogging and unanticipated hammer firing“

Expectation: Roughly 100' of unconsolidated overburden covering competent marble bedrock – the softest and easiest to drill rock type in NYC!

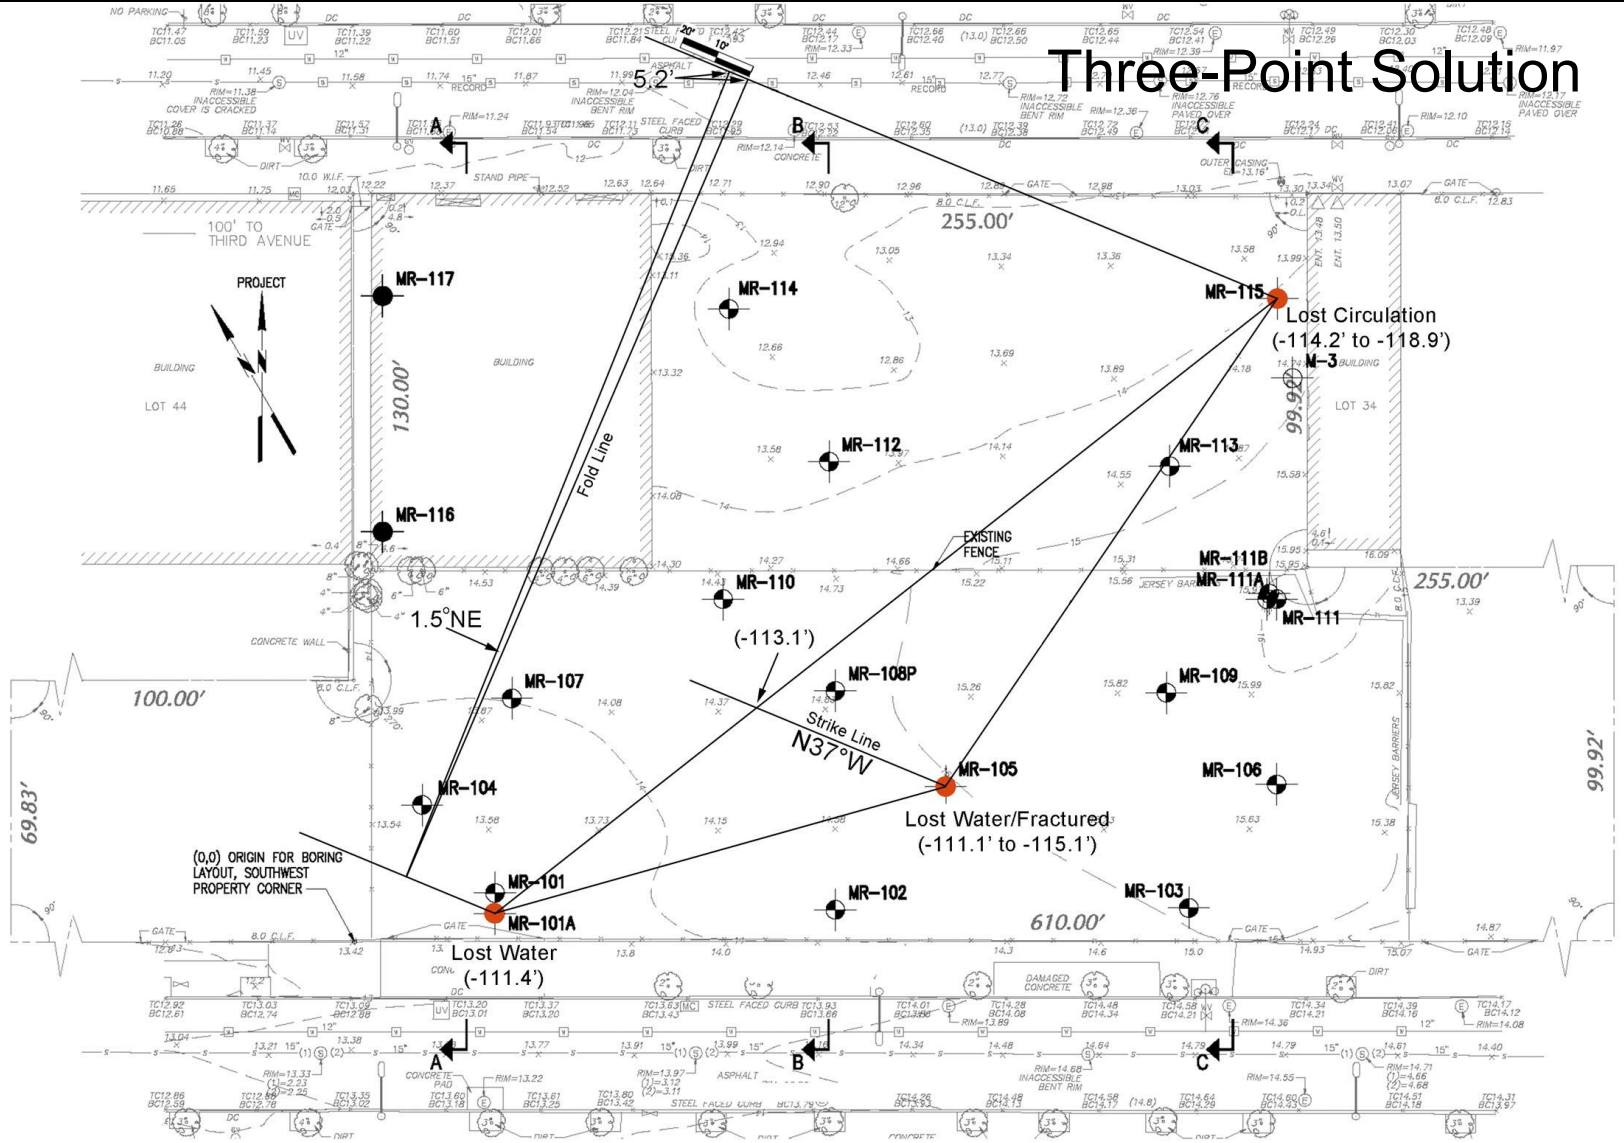
Upper Fracture
Three-Point Problem #1
MR-101A/MR-105/MR-115
Solution = N37°W, 1.5°NE
